FABRICATION AND VERIFICATION TESTING OF ETM 30 CM DIAMETER ION THRUSTERS

FINAL REPORT

APRIL 1977

ION PHYSICS DEPARTMENT STAFF
HUGHES RESEARCH LABORATORIES
A DIVISION OF HUGHES AIRCRAFT COMPANY
3011 MALIBU CANYON ROAD
MALIBU, CALIFORNIA 90265

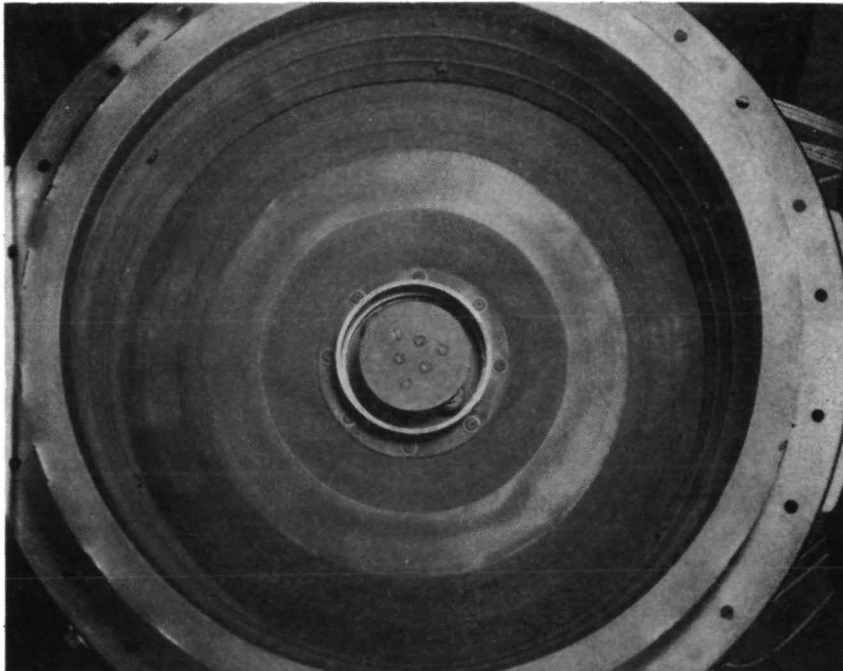
(c) Discharge-chamber backplate and anode

A second detrimental effect of discharge-chamber erosion experienced in the endurance test of thruster 701 was spalling of the material which had been sputter deposited on surfaces not subjected to erosion. The deposited material spalled off in flakes of sufficient size to bridge the interelectrode gap of the optics, thus shorting out the ion-extraction voltage.

Figure 27. Continued.

deposited. This can be done in two ways: grit blasting and covering the surface with a fine stainless-steel wire mesh. Both techniques were used in the 900-series thruster. Table 7 itemizes the sites where these flake-control methods were applied within the discharge chamber. Figure 27 illustrates how the stainless-steel mesh was added to various components.

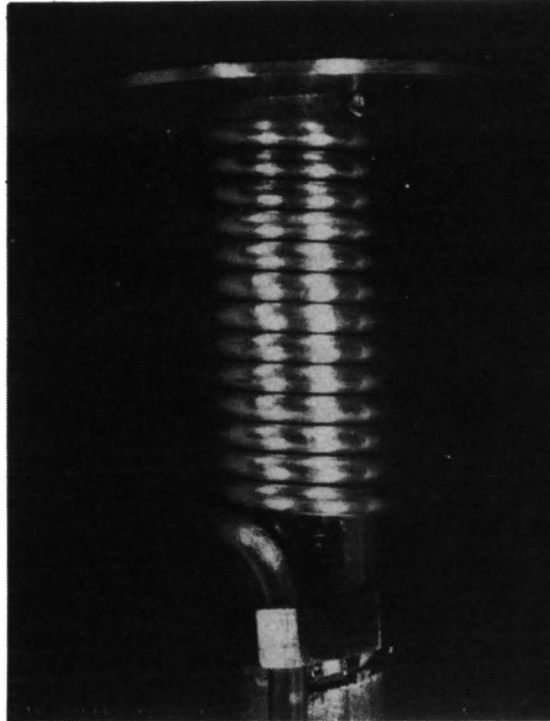
Figure 28. Main cathode of thruster 901 showing sheathed heater used in 900 series design.

In the 900-series thrusters, two changes from the 800-series design were made in both the main and neutralizer cathodes. First, impregnated porous tungsten inserts replaced the rolled tantalum foil inserts. Second, sheathed coaxial heaters replaced the flame sprayed ceramic encapsulated tip heaters.

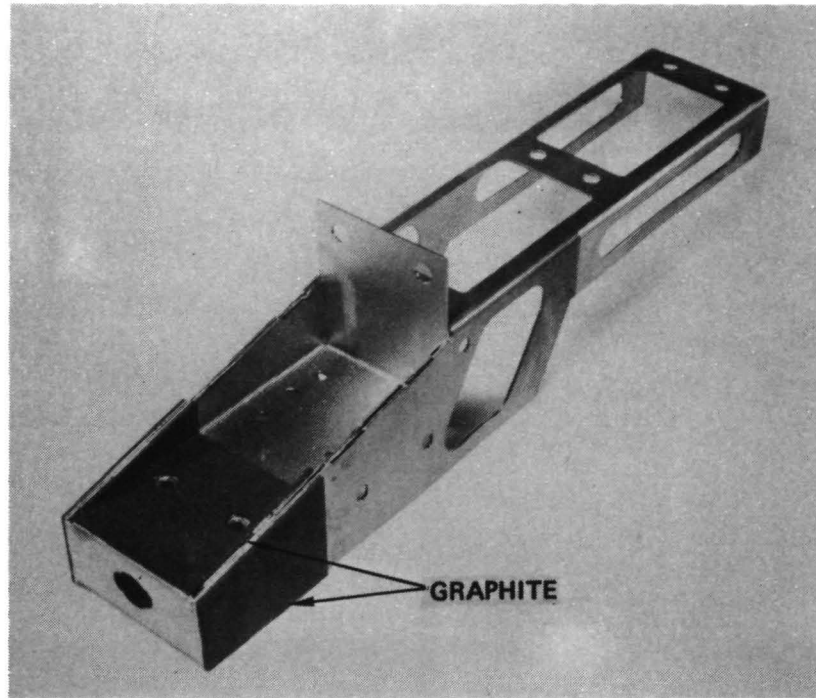
Figure 29. 900-series neutralizer bracket showing graphite added to reduce erosion.

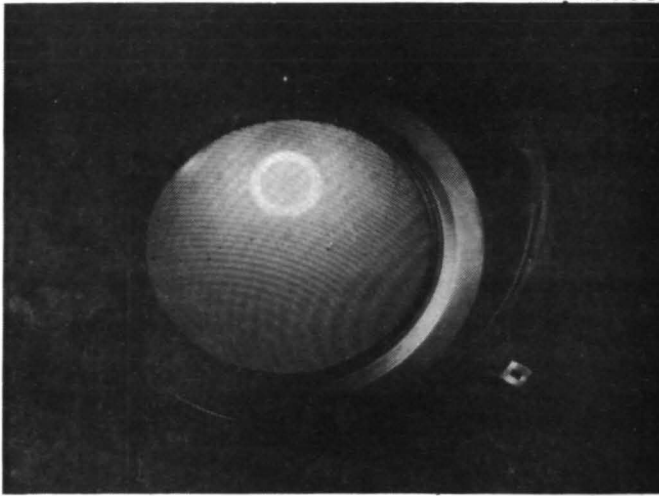
1800 hours

The first evidence of thruster discharge chamber erosion was the observation at test hour 4530 of flakes lying on the upstream side of the screen grid (the thruster was mounted in the vertical vacuum chamber pointing down at a frozen mercury collector). The number and size of flakes varied as the test continued; Figure 31 illustrates this by showing the flakes at test hours 8600 and 10,000. Some of the erosion of the accelerator electrode apertures caused by the flakes is shown in Figure 32. In that figure, the uneroded apertures adjacent to eroded apertures demonstrate the localized nature of the erosion. The source of flakes on the screen electrode is presumed to be spalling of the material which had been sputter eroded from within the discharge chamber and deposited on other discharge chamber surfaces. This theory was substantiated at test hour 5845 when a small hole was observed in the center of the cathode baffle. The cold-rolled steel baffle had originally been 0.075 cm thick. The maximum dimension of this hole when first observed was approximately 0.4 cm. Additional erosion of the cathode baffle then appeared at two locations on the edge (see Figure 31). The two regions of edge erosion began diametrically opposite each other and appeared to be coincident with the axis of the cathode keeper; the cathode keeper is mounted 1.7 cm upstream from the baffle. The condition of the baffle at the conclusion of the 10,000 hr test is shown in Figure 31.

Figure 31. Thruster at test hours 1800, 8600, and 10,000 showing flakes on the optics and erosion of the baffle.

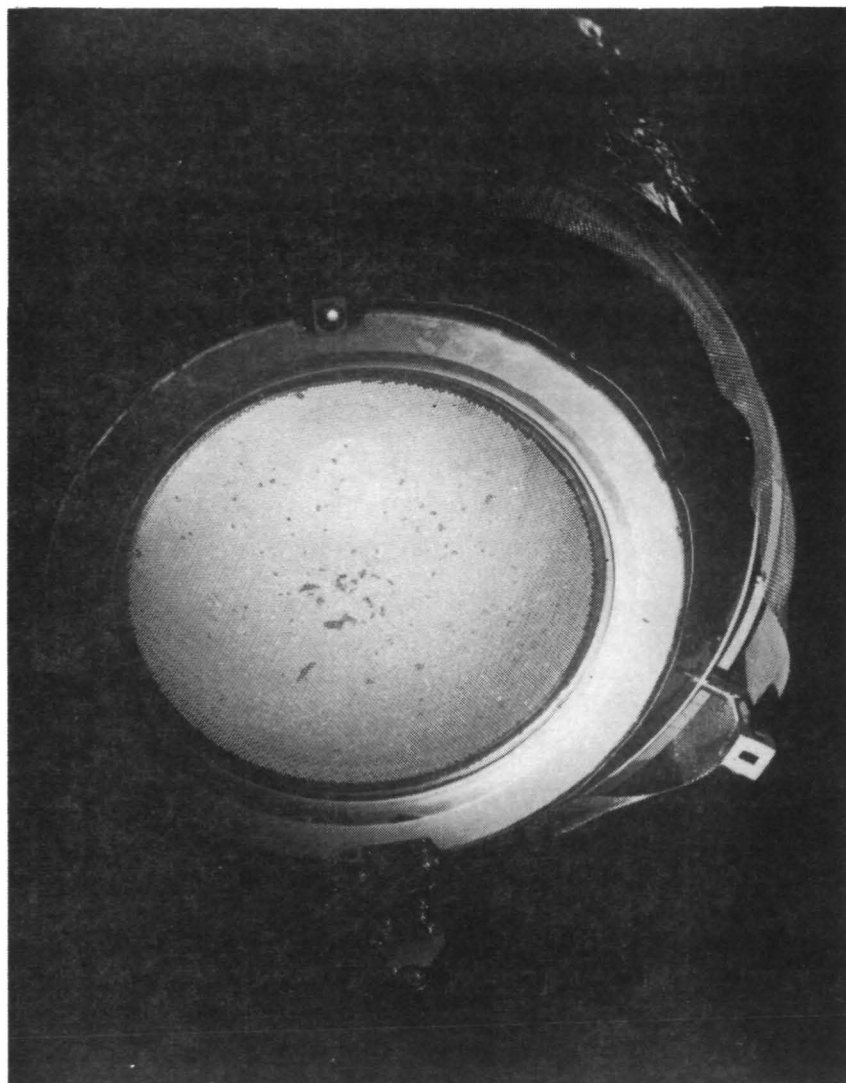
Figure A-1. Thruster during final hours of 10,000 hr test.

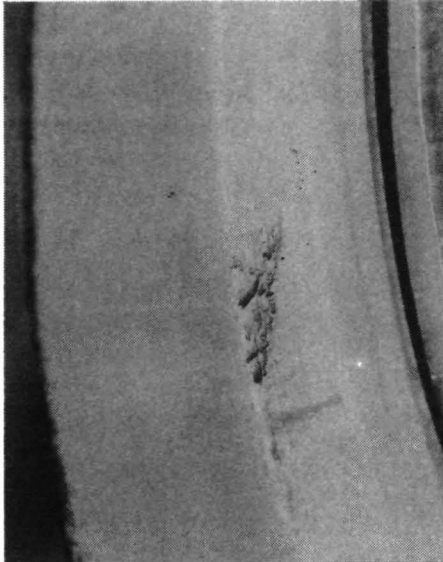
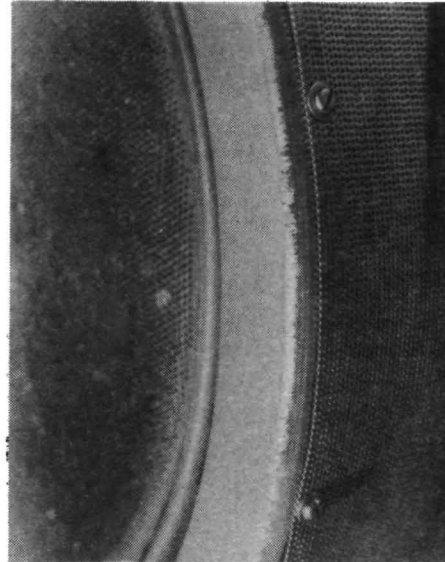
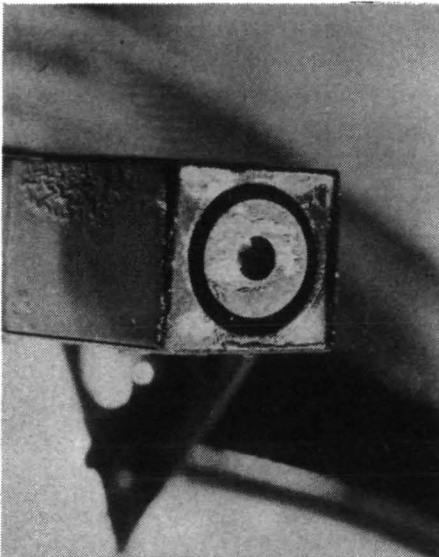
(a) DEPOSITION ON DOWNSTREAM SURFACES OF OUTER CASE MASK

(b) DEPOSITION ON NEUTRALIZER
SN 415

Figure A-3. (a) Deposition on downstream surface of outer case mask. (b) Deposition on neutralizer SN 415. (c) Damage to accelerator apertures.

would be essentially equivalent for locations I, II, and III, it is concluded that the deposits of stainless-steel constituents found on the downstream surfaces of the thruster case are caused primarily by ion beam sputtering of the cryowall. Sample IV was a single flake that was lodged in a grid aperture and is seen to be predominantly molybdenum. The molybdenum found in all these samples is presumed to originate from the electrodes of the ion optics assembly. Three forms of erosion of grid material can be observed; a thinning of the screen grid electrode by discharge chamber ions, machining of the accelerator electrode by direct interception, and charge exchange erosion on the accelerator electrode. No technique has been devised, as yet, to determine how much each of these processes contributes to the deposition. The ion optics electrode wear will be discussed in more detail in a later section.

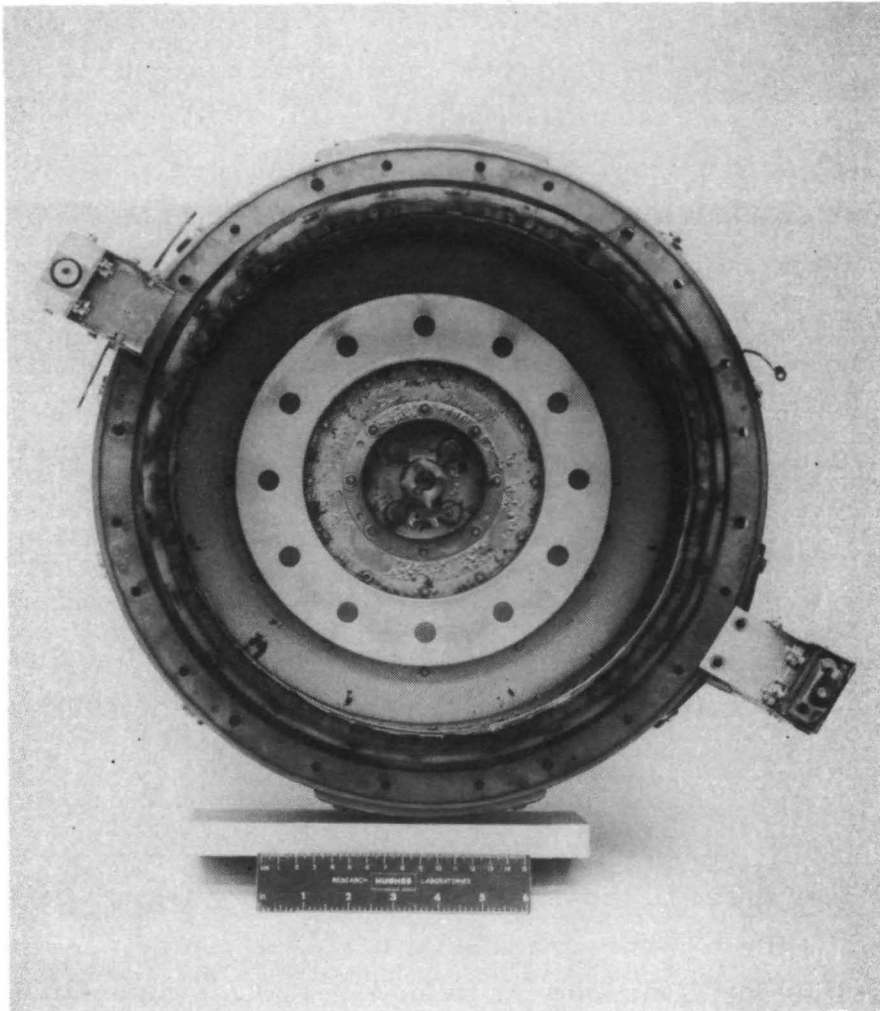
Views of the thruster assembly taken during initial disassembly are shown in Figs. A-5 through A-12. In Fig. A-5, the major wear of the thruster baffle and cathode pole is visible as well as its consequence, the deposition of the sputtered material on the thruster backplate and anode. This wear and its consequences will be discussed in detail in the following sections covering the discharge chamber assembly and the cathode pole/baffle assembly.

Figure A-5. Thruster 701—front view with optics removed.

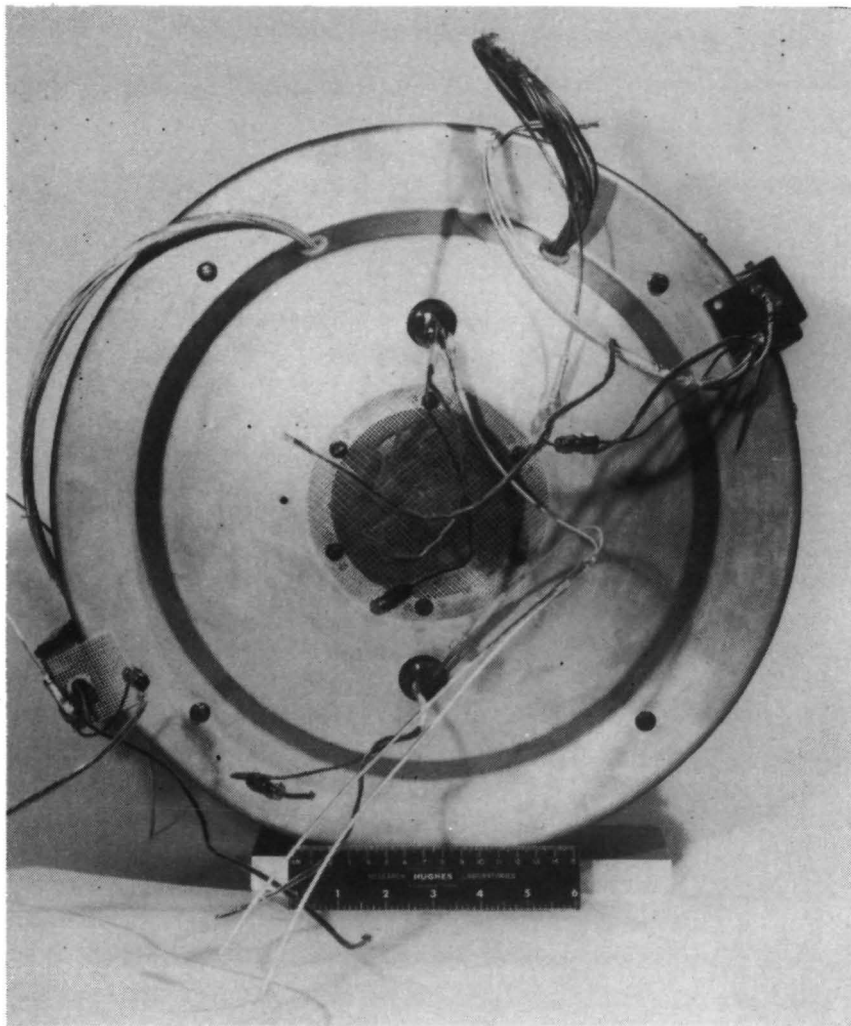
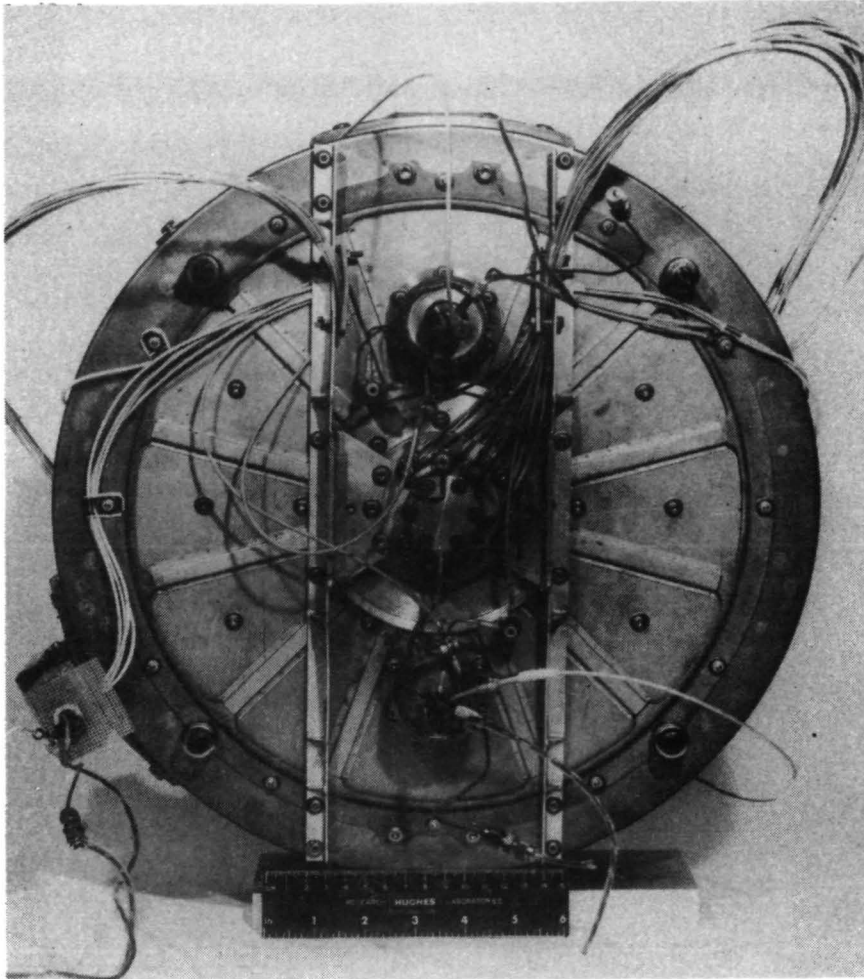
Figure A-8. Thruster 701—rear view.

Figure A-9. Thruster 701—rear view with rear cover removed.

Figures A-8 and A-9 show the thruster as viewed from an upstream location, with and without the back outer case. On the basis of what can be seen from these photographs, it would be impossible to estimate how long the thruster has been operated. The slight discolorations seen on the vaporizer and central access plate of the back cover are considered to be a consequence of wiring insulation deterioration. Other evidence of this deterioration is seen in Figs. A-10 and A-11. The wires affected are attached to or are routed very close to components that operate at relatively high temperature ($\sim 300^{\circ}\text{C}$). Notice also the relatively large number of mercury droplets seen on the thruster surface in Fig. A-11. This mercury is thought to be a consequence of the vacuum chamber venting and thruster dismounting procedures rather than deposits which have condensed during the test.

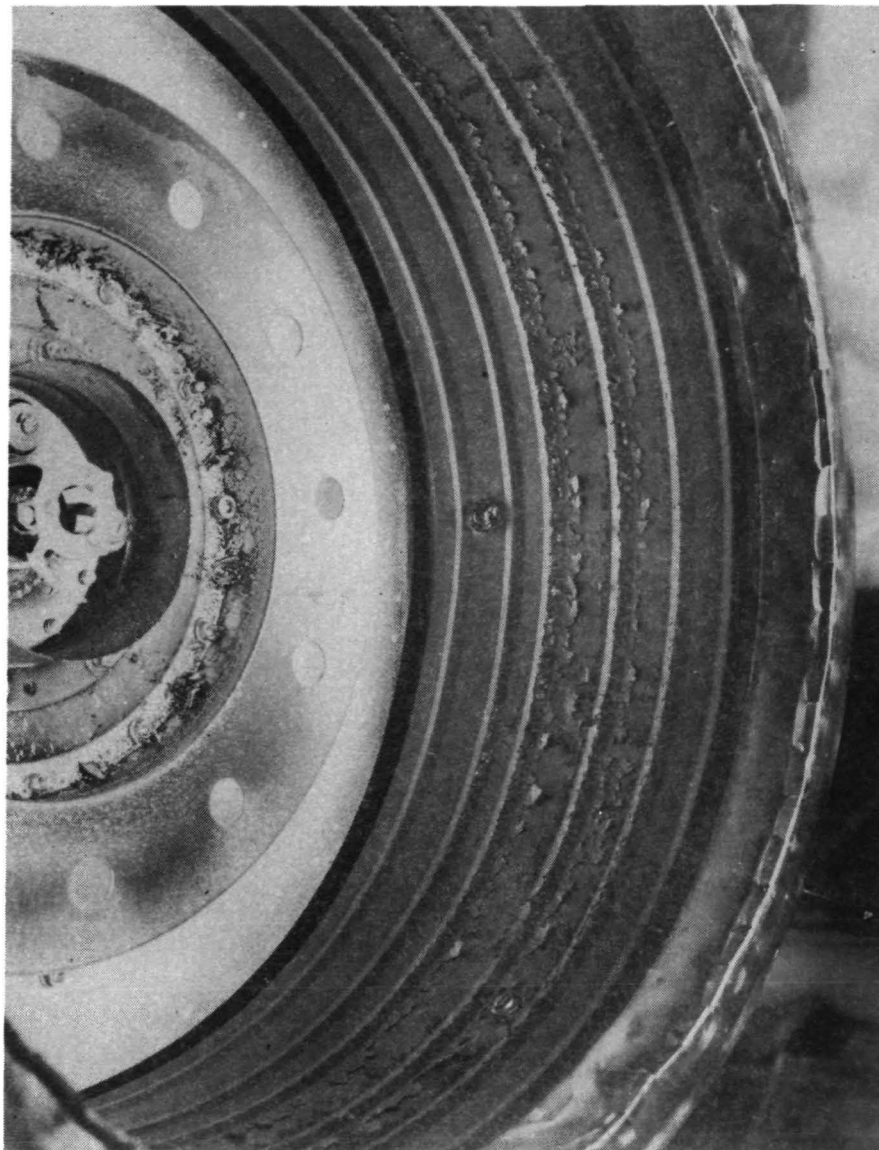
Figure A-17. Sputter deposition on anode.

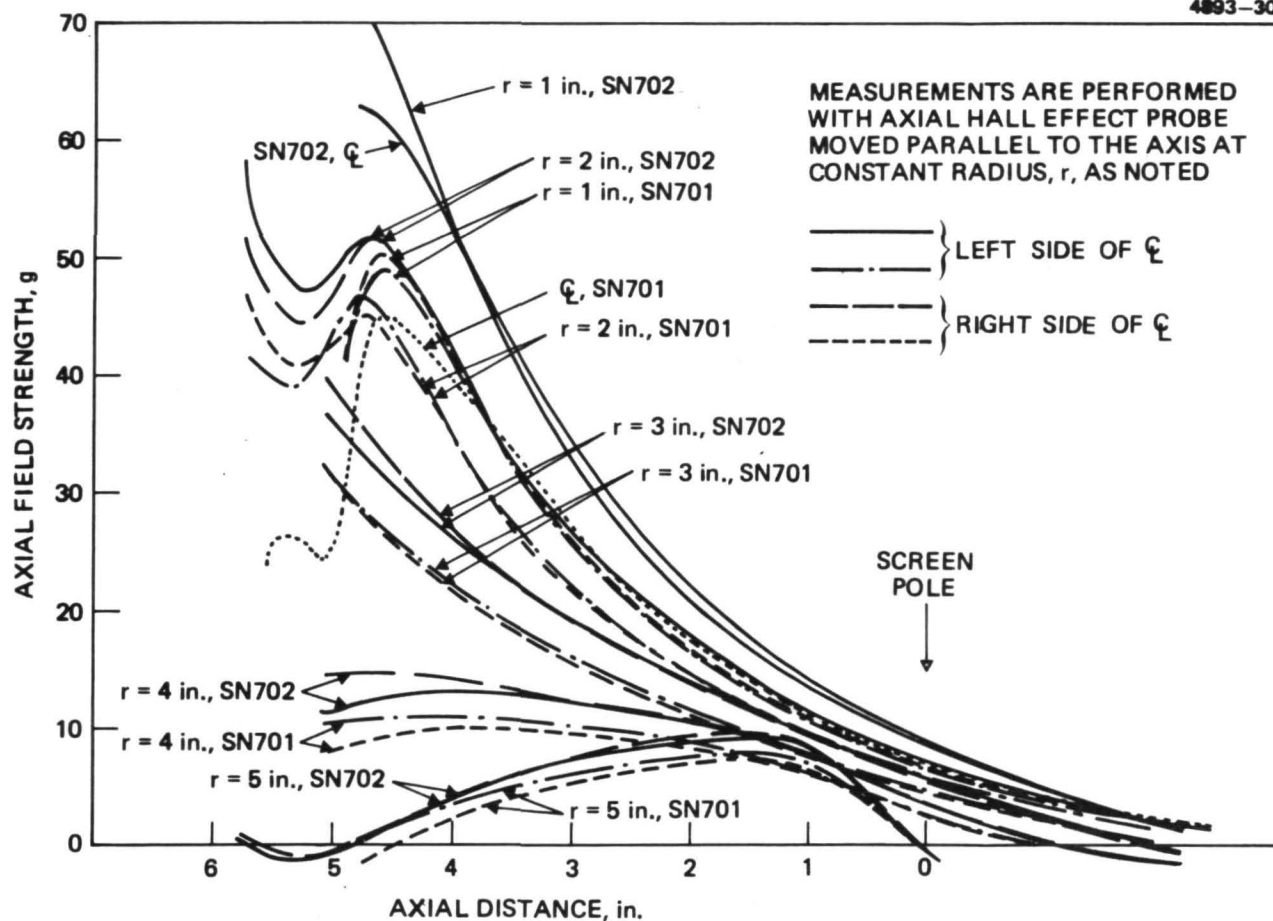
Figure A-18. Comparison of axial magnetic field components of thruster SN 701 after 10,000 hr test with those of thruster SN 702.

Figure A-19. Comparison of radial magnetic field components of thruster SN 701 after 10,000 hr test with those of thruster SN 702.

required for each of the radial magnets is 4.8 to 5.0 G, as measured in the calibrating fixture. The measured values of the radial magnets from thruster SN 701 vary in strength between 4.35 and 4.9 with an average value of 4.5. Thus, assuming that these magnets were originally the same as those being used now, the magnetization appears to have decreased by at least 6% below the value considered to be minimum in new thruster fabrication. This decrease in magnetization can account for at least a part of the generally lower magnetic field components of thruster SN 701 as compared to thruster SN 702 in Figs A-18 and A-19.

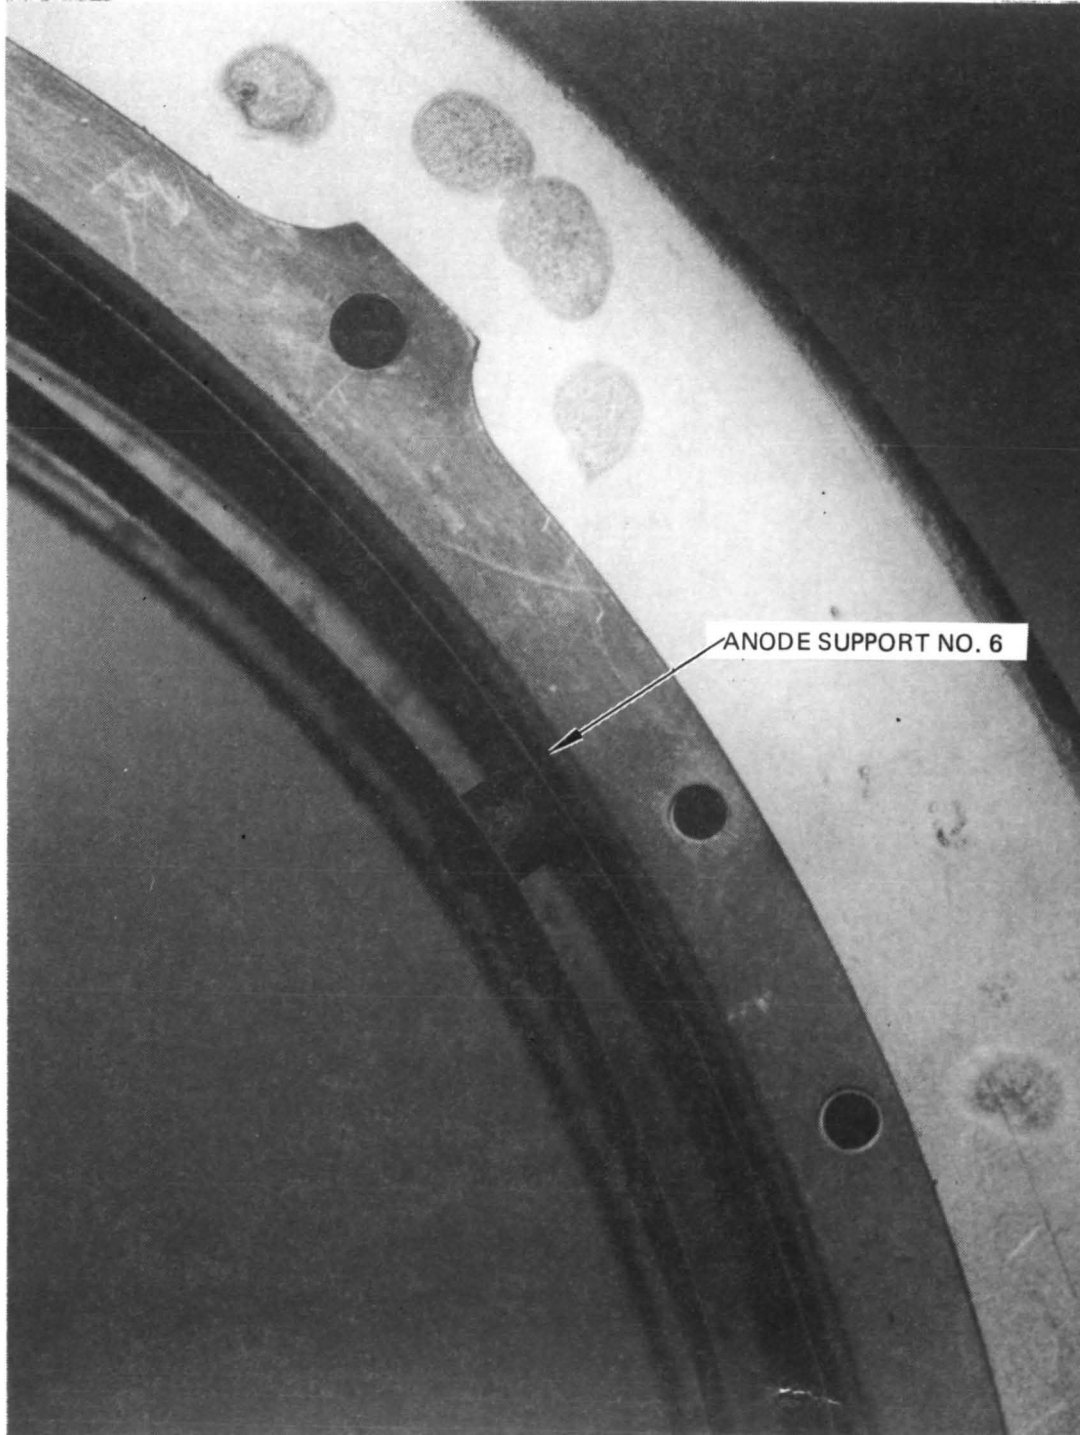
The thruster backplate was removed to expose these support insulators; upon inspection, the ceramics were seen to have sustained damage, as shown in Figs. A-23 and A-24. The damaged insulators were removed intact by cutting the anode and discharge chamber shell with a high-speed abrasive wheel. Removal of anode support number 2 (current connection) resulted in an increase in the leakage resistance, as measured with the "megger" 1 kV ohmmeter, to 10 k Ω . The megger measurement was seen to fluctuate to readings as high as 25 k Ω . Removal of the other damaged support, number 6, did not appreciably change the leakage resistance. Figures A-25 and A-26 show all sides of the damaged anode supports after removal from the discharge chamber. The leakage resistance measured across these insulators was approximately 10 k Ω . Removal of the third upstream anode support, number 4, by normal disassembly increased the leakage resistance to a value fluctuating between 30 and 200 k Ω ; sparking was seen around the downstream insulators. The remaining anode supports were removed with care taken to preserve a record of their orientation. The ceramic insulators removed are shown in Fig. A-27.

Figure A-24. Anode support No. 6 in place.

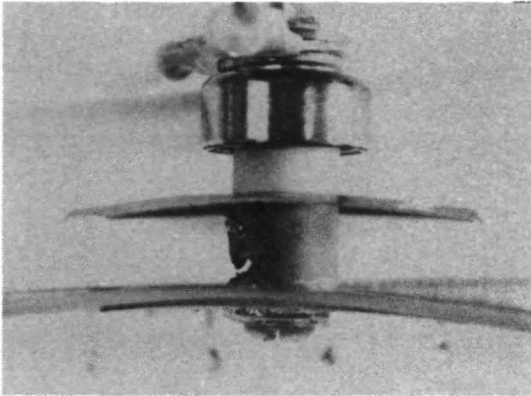
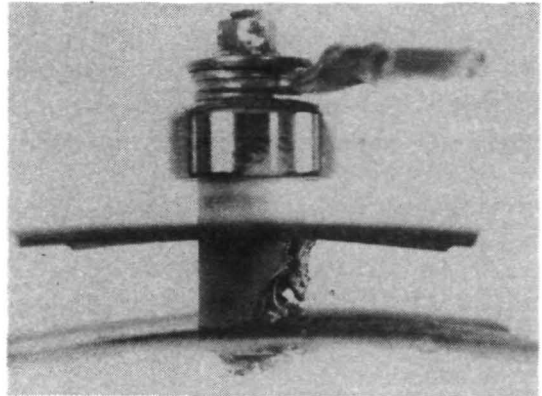
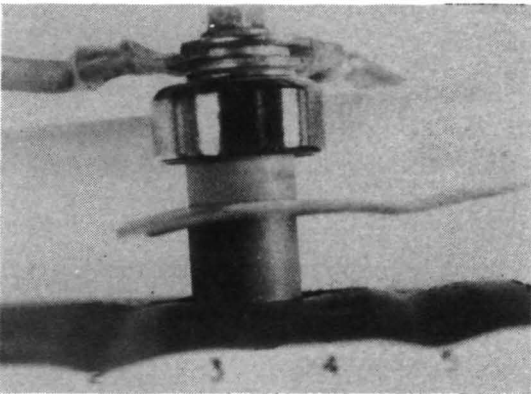
Figure A-25. Damaged anode support No. 2.

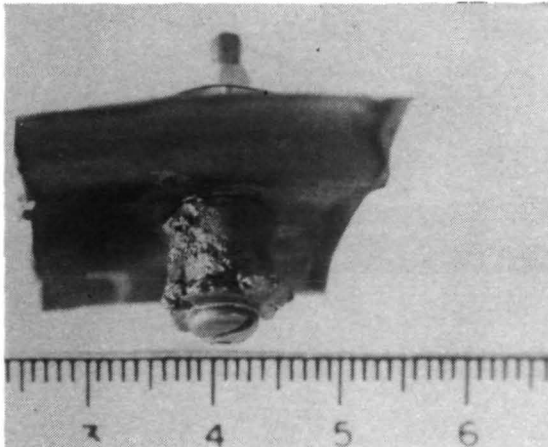
Figure A-26. Damaged anode support No. 6.

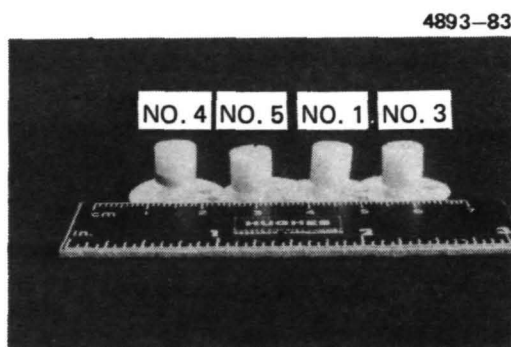
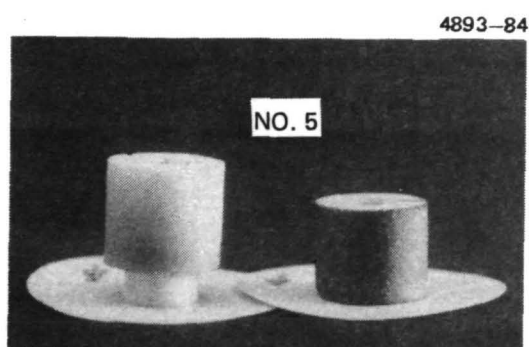
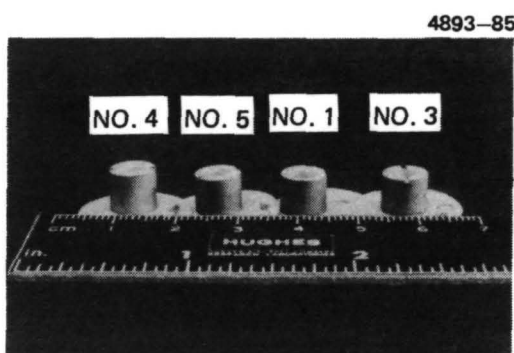
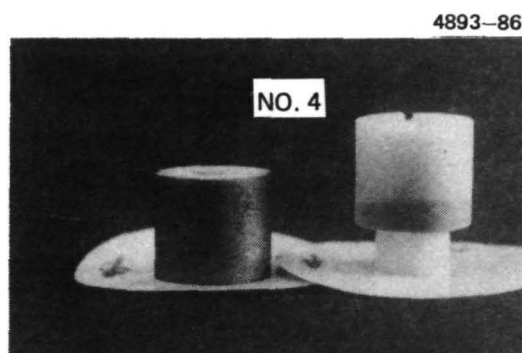
The ceramic parts shown in Fig. A-27(a) are the portion of the anode support insulators which are located on the exterior side of the discharge chamber shell, while those shown in Fig. A-27(b) are located between the anode and the shell. The exterior insulators have a shield and are only slightly coated on the downstream surface (arrows seen on insulator tags indicate beam direction). The interior insulators are not shielded, except by means of their location between anode and shell, and are coated more or less uniformly with no indication of the orientation of the source of the deposited material. The nature of this coating will be discussed later. Figure A-27(c) and (d) show the opposite views

Figure A-27. Cermaic insulators from anode supports
Nos. 1, 3, 4, and 5.

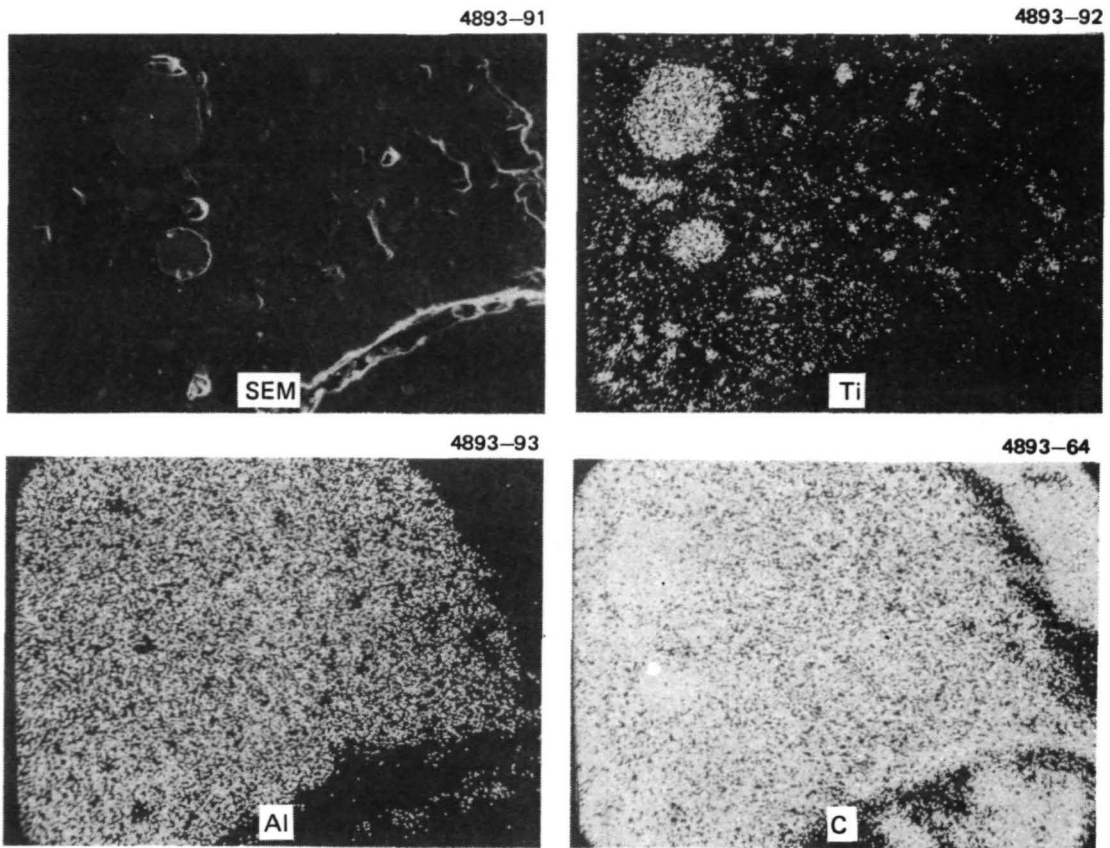
Microscopic examination of Area 2 shows that the titanium discharge chamber shell is eroded on the interior surface adjacent to the point of contact with the ceramic anode support insulator and that this ceramic has been melted in the vicinity of this point of contact (see Fig. A-33(b), 50X and 500X). Melting of the ceramic is indicated by the dendritic structure of the cross-sectioned ceramic. Titanium appears to be distributed throughout this melted region of the insulator, which would imply some sort of "wicking" or melting. This latter observation was substantiated by the SEM X-ray scan shown in Figs. A-35(a) and (b). The elements contained in this area are, in decreasing order of concentration, Al, C, O, Ti, Si, and Ca (the high percentage of C may be a consequence of the carbon coating necessary to prevent the sample from charging up in the SEM). Thus it appears that the interaction seen between the anode and the anode support elements is a consequence of melting. Considering the elements involved, the lowest melting point eutectic that could occur would be for Al and Ni at 640°C. All other binary combinations yield higher melting points. This temperature is well above ambient for any part of the discharge chamber (excluding the cathode tip). Although the presence of mercury might have some influence on the metallurgical behavior, it is considered more probable that intense heating occurs during some form of transient occurrence such as a vacuum arc across the insulator surface.

Figure A-35. Continued.

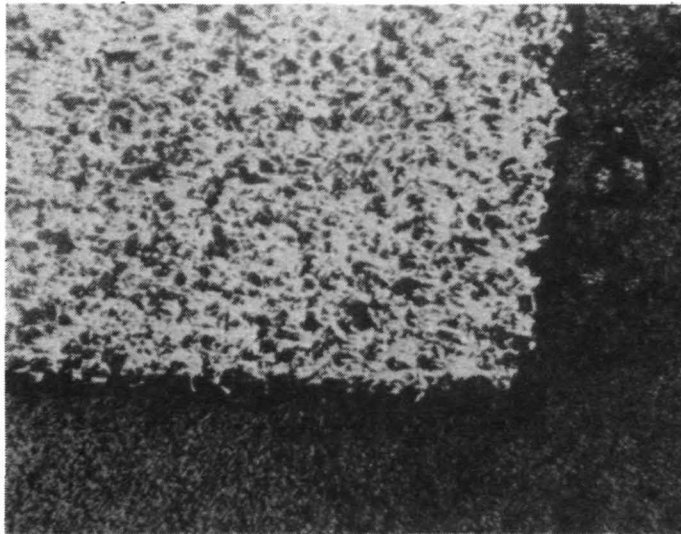
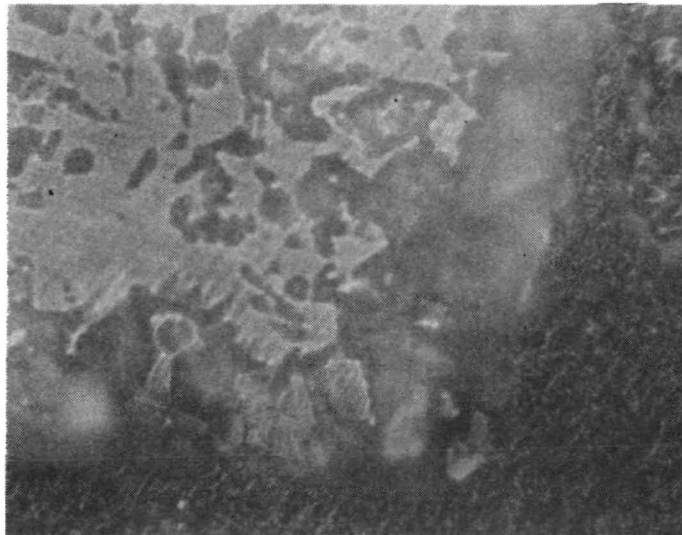
On the supposition that some form of insulator deterioration might have contributed to initiation of the phenomena that resulted in melting of the anode support insulator, the ceramic material was examined further in the areas shown as 3 through 8 in Figs. A-31 and A-32. The magnified photograph of Area 3, shown in Fig. A-36(a), seems to show a coating of about 4 μm thickness. An attempt to scan the coating in this area with the SEM microprobe showed only the elements C, Al, O, Ca, Si, and Cl. A second attempt in Area 6 produced Ti and Fe as well (SEM and the Al K_{α} X-ray scan are shown as Fig. A-37). Area 4 is in the damaged area, and it was thought that if the ceramic, which is predominantly Al_2O_3 , was reduced to produce elemental Al, it would be possible to detect this by comparing the

Figure A-36. Magnified view of regions 3, 7, and 8 of anode support No. 6.

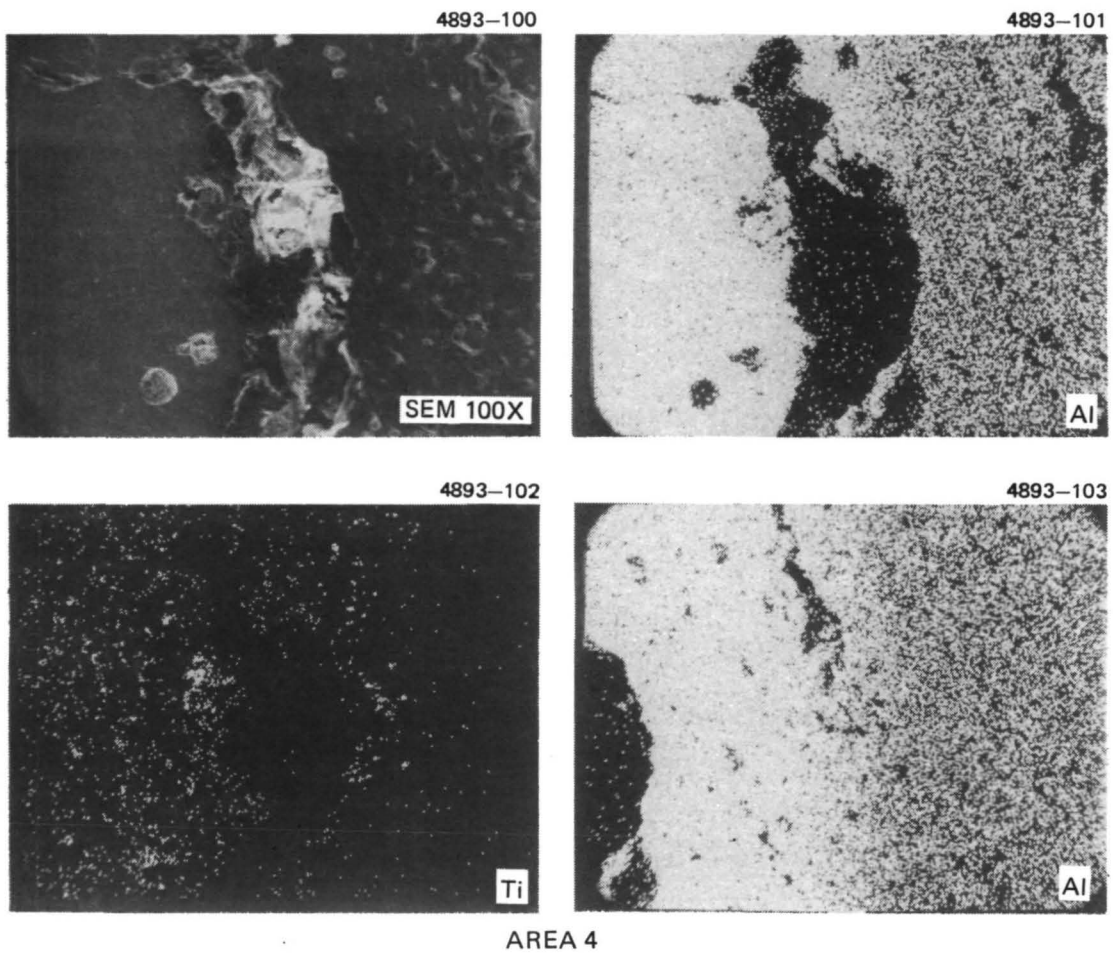
relative concentrations of Al and O in the damaged and undamaged areas. Figure A-38 shows an attempt to compare the Al signals from the SEM microprobe. Although it appears that the damaged area (left side of the void) has a greater concentration of Al in Fig. A-38, this is not necessarily the case, as shown by Fig. A-38 where the scan field has been shifted slightly. Thus, the apparent gradation in the concentration of Al depends more on the scan location than on the location in the material. Area 5, which is located in what is thought to be undamaged material, shows no real variation in concentration of Al, no titanium; the remaining impurities, Si and Ca, seen in Fig. A-39 are probably remnants of the polishing compound trapped in the normal voids of the Al_2O_3 . Areas 7 and 8 appear identical to area 5 under the microscope, and no coating was discernible on the insulator surface. Consequently, these areas were not examined further with the SEM microprobe.

Figure A-38. SEM photo and K_{α} X-ray analysis of area 4 of anode support No. 6.

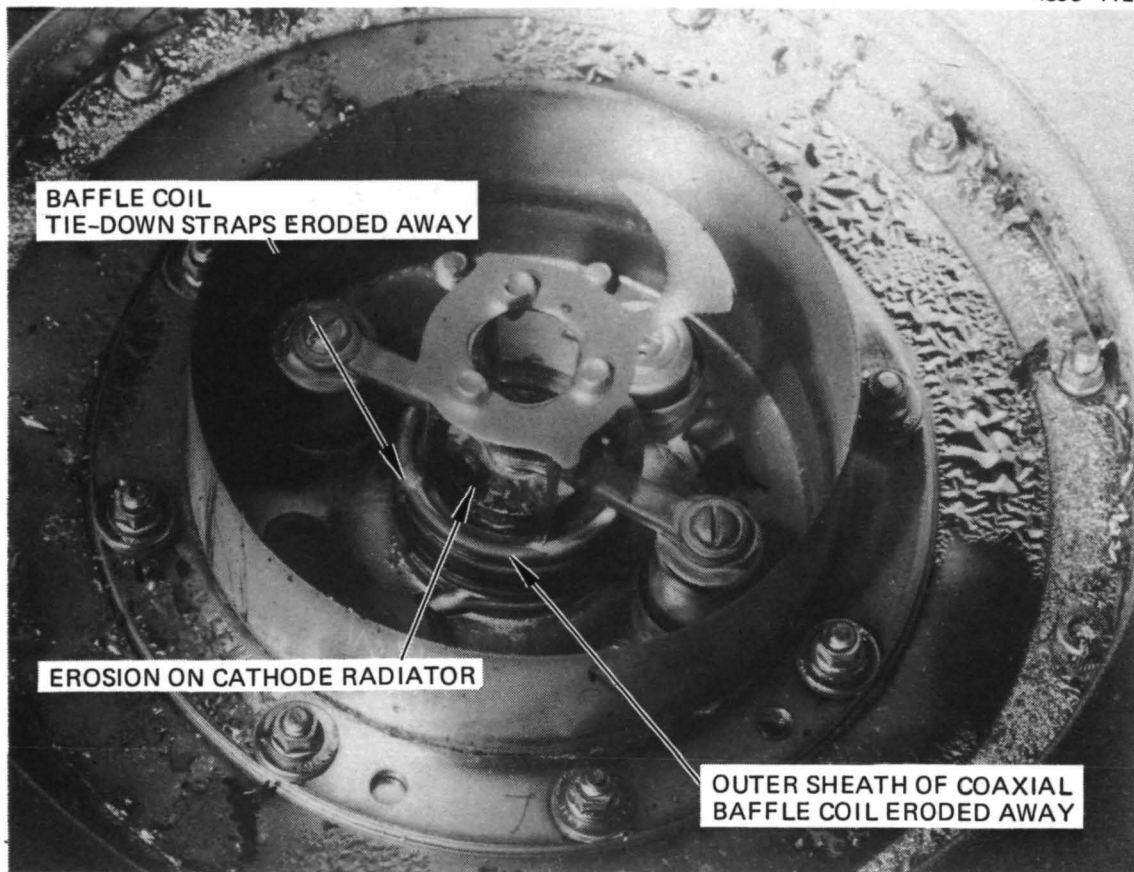
Figure A-44. Cathode pole piece/magnetic baffle assembly.

heavily deposited. The erosion patterns have an imperfect symmetry that seems related to the orientation of the baffle coil terminations. The outer conductor of the coaxial baffle coil is seen to be eroded away in Fig. A-44, exposing the insulator over a relatively large area, while the counterpart of the coil seen in Fig. A-43 shows penetration of the coils outer sheath over a relatively smaller area. Similarly, a remnant of the baffle coil tie-down strap can be seen on the downstream side of the coil in Fig. A-43, whereas the counterpart strap is seen in Fig. A-44 to be completely eroded away on the downstream end and barely visible on the upstream end. It has not been possible to formulate a cohesive explanation for the erosion seen on the baffle coil and cathode radiator. The generally accepted model of the discharge chamber plasma potential distribution would place the plasma potential within the cathode pole piece at approximately the keeper voltage. Thus, no doubly charged ions should be formed in the region and singly charged ions should not be capable of causing damage. It is possible that this erosion is entirely a consequence of exposure to high-energy ions from the discharge chamber after the baffle was eroded away. However, taking note of the pattern of baffle wear in these photographs, it is apparent that remnants of the baffle show a "spoke-like" configuration and these remaining elements are aligned with the four baffle support members. This could be interpreted as a shielding of the baffle from ions originating within the support structure or as a magnetic field effect. No conclusive evidence exists to determine whether the erosion pointed out in Fig. A-44 is "typical" or a consequence of operation without the baffle.

It is apparent in Figs. A-43 and A-44 that removal of the machine screws which secure the baffle to its support is a questionable operation because of the erosion of the baffle supports, which weakens the structure, and because the heads of the screws are eroded to the extent that they cannot be gripped by any tool. After several unsuccessful attempts at removing these screws, the entire support was removed with a high speed abrasive wheel. Several photographs showing the structure as it was removed in several views and variations in focus are included in Fig. A-51. Note that the erosion on the baffle fastening screws is predominantly on the inner side. It is also of interest to note that a thin lip of the baffle remains extending beyond the outer diameter of the baffle support, as if the baffle had been shielded from internally generated ions by the baffle support (further evidence to support the concept of erosion by ions from the cathode plasma). The wear on this structure is documented and recorded in Fig. A-52 by dimensional measurements at the locations indicated. The most wear occurred on Member C, in agreement with the asymmetry in wear seen on the baffle itself and the pole piece.

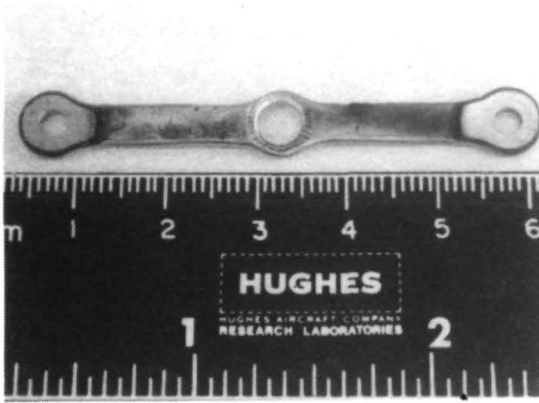
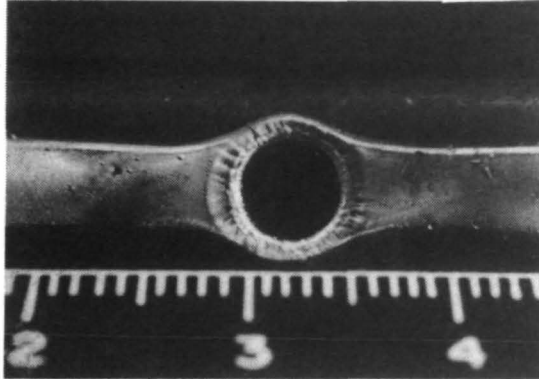
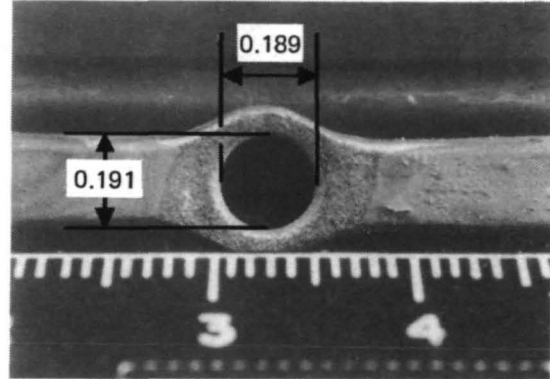
Figure A-46. Cathode keeper.

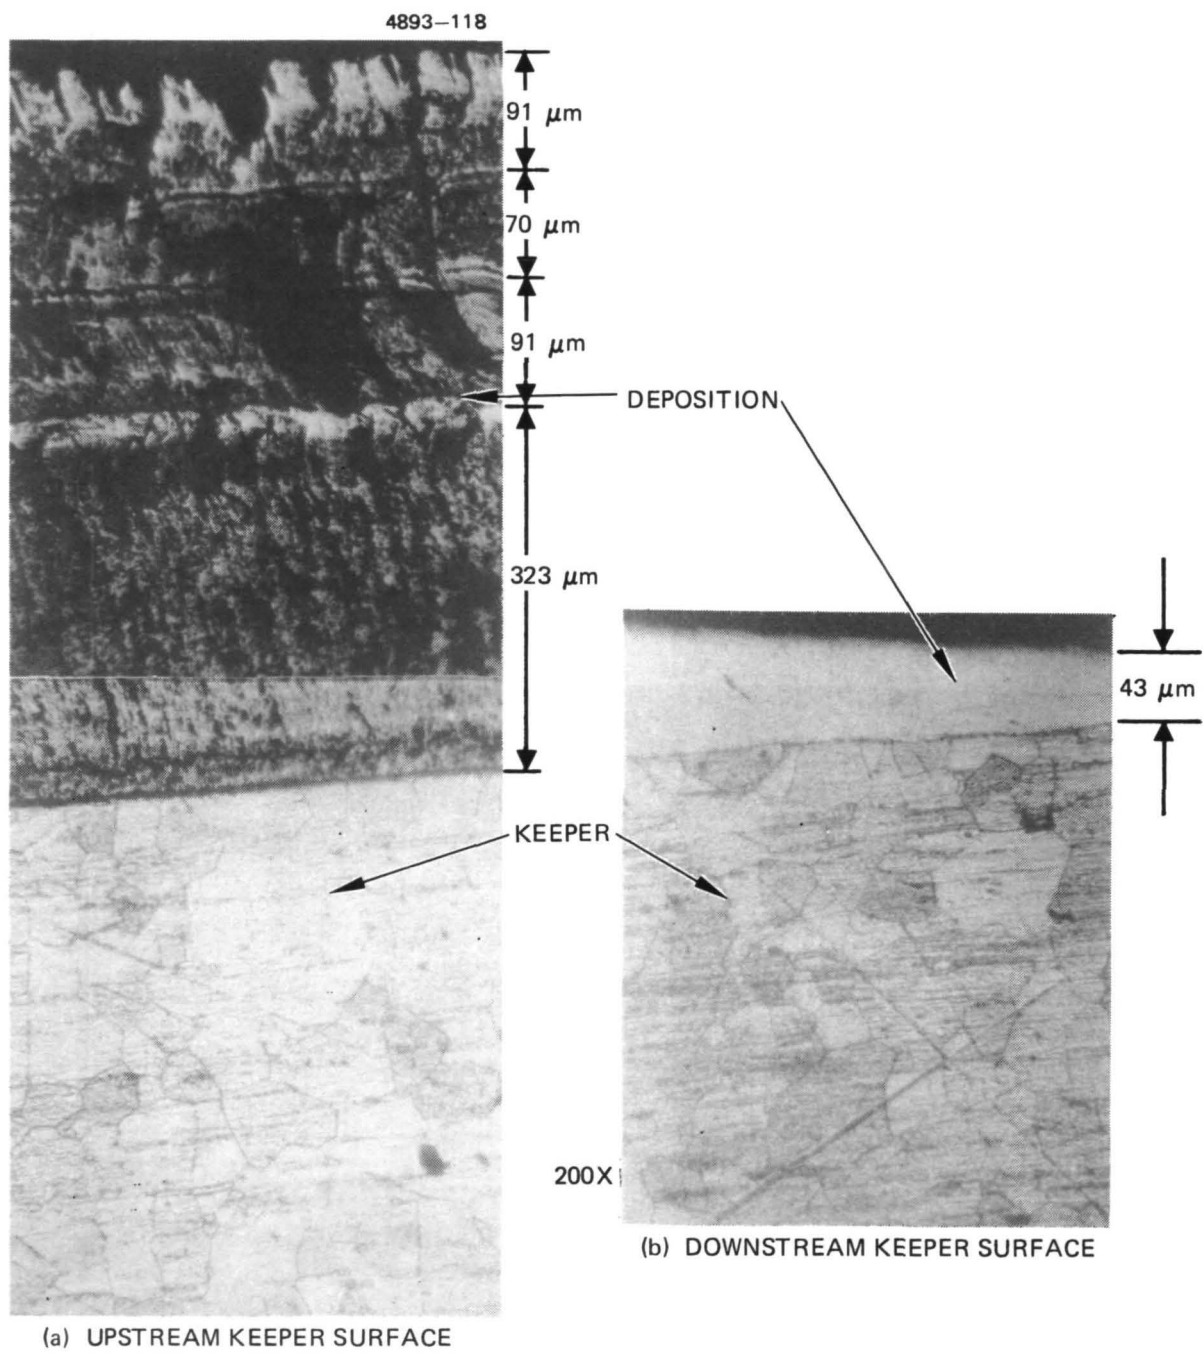
It was thought that a detailed analysis of the keeper deposits might offer some explanation of the erosion process or history and the sectioned keeper was analyzed using the E-beam microprobe. The "layered" appearance of the upstream coating seen in Fig. A-48(a) can also be seen in the SEM photograph and to some extent in the elemental analysis scans of Fig. A-49. The elements found were Fe, Ta, Ni, Cr, and K. Since the distribution was more or less uniform throughout the coating, it was not possible to establish a time history based on an abrupt appearance of one of the elements. The Fe, Ni, and Cr are thought to originate in the stainless-steel baffle coil sheath and tie-down straps, while the Ta originates in the cathode radiator. Next, an attempt was made to relate the layer thickness to test events as indicated in Table A-5, starting the layer formation at either the start of the test or at the appearance of the hole in the baffle. Changes in thruster beam current were selected as the test events for correlation. As shown in Table A-5, there is no significant relationship between the selected test events and the layer structure (thickness).

Figure A-48. Magnified views of cathode keeper.
